EXAMINING THE BUCKET WHEEL EXCAVATOR'S BUCKET AFTER RENEWAL

Abstract: The Department of Geotechnical Equipment is involved since two decades in research and development of teeth, buckets and other active parts of different kinds of mining excavators. The actual study is devoted to reveal new difficulties arising when excavating in the sandstone as overburden rock, mainly regarding the buckets of Bucket Wheel Excavators. As a consequence of the increased cutting forces, the buckets suffer deformations. In case of the change of cutting geometry, as a result of renewal (strengthening) of buckets, the winning becomes no-optimal and there will be more breakdowns. The investigations made and reported in the actual paper led to provide guidelines for a better renewal method of buckets.

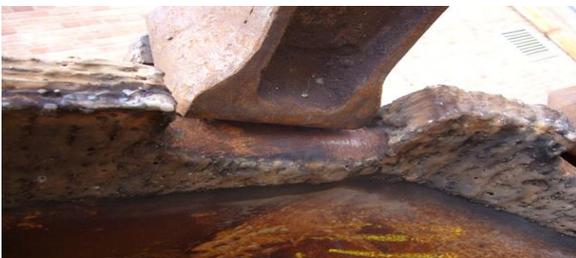
Fig. 3. The deficiency of the relative position of the tooth on cutting blade at the renewed buckets

- A general deficiency, – present at ~95% of teeth – the tooth is located in the teeth support (adapter) in such a manner that it is not fitted on the cutting blade of the bucket.

The main load carrying element of the bucket is the cutting blade together with the tooth support. Since analyzing the case of opened cutting buckets, it is obvious that even this kind of bucket is capable to support the nominal loads. For this reason, during the design process, we considered as a preliminary condition that a part of the cutting forces acting on the tooth to be transferred to the cutting blade. If this condition is not fulfilled, i.e. the tooth is not supported by the cutting blade, the tooth adapter, by its welded joint to the blade is enforced to transfer all the forces acting on the tooth towards the cutting blade. The welded joint is only partially capable to do this. It is dimensioned in such a manner, that if the forces acting on the tooth exceed the nominal value, it is better to fail the welded joint protecting in this way the damage of the bucket. Or, in the working environment in which the analyzed BWE and buckets operates, due to the hard sandstone inclusions, it is very frequent the case in which the cutting forces exceeds more times the nominal value. Previously performed tests in order to find out the values of cutting forces, on samples collected at Visonta and Bükkábrány mines, [3] indicated that the ratio of cutting forces in clay to cutting forces in sandstone is about 1:14, which means that peak forces may increase with more than 1 order of magnitude.

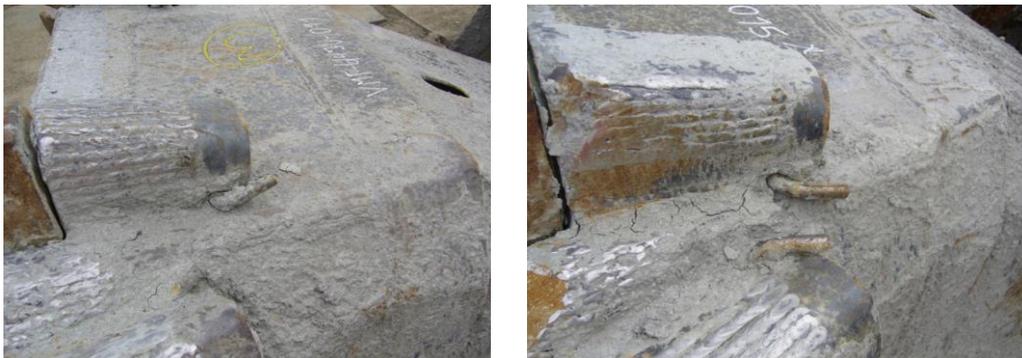
- The tooth adapters are not well positioned (located) in many cases. The incorrect setting of tooth adapters in the positions near to the connecting edges of the cutting blade can be observed even visually without any measuring device. In the figures 4-5 we can easily observe the wrong distance between two adapters located in the vicinity of the connecting edge between front plate and lateral plate of cutting blade.

Fig. 4-5. Wrong positioning of the tooth adapters on the renewed buckets

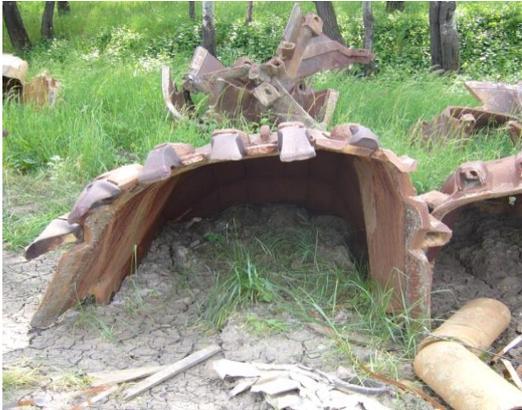
The intervals between adapters of the cutting blade, during renewal are burdened with weld, so they lose the “cutting edge” character, as it can be seen in figure 6. It is recommended that, during renewal to maintain the initially – prescribed in the design- chamfered edge.

Fig. 6. Renewed cutting blade with adapters

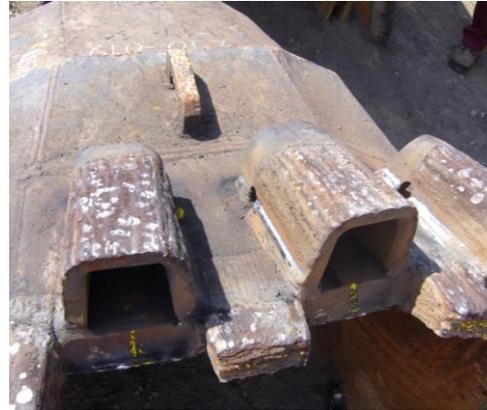
Fig. 7. Failure of teeth

• Also, we have had suspicions about the constant character of the teeth's material. The experience revealed that after different renewal cycles, teeth made from different quality of material were mounted on buckets. The figure 7. illustrates the evidence of such a situation. We can see on the same bucket bent teeth together with broken ones. That indicates that the quality of teeth's material varies in a very large range.

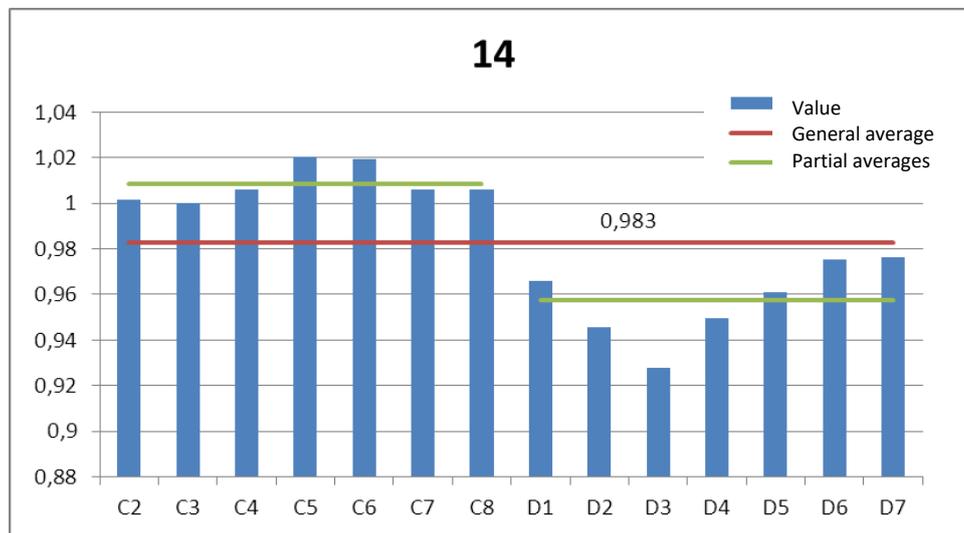
Fig. 9. Relative deviations diagram for the bucket no. 14

As it can be seen, the average value of the relative deformations (red line with value above) is not very high, being under 2%. But if we analyze individual values, we find greater deviations, as the D3 value on figure 9 is 92,8% of the average value, so the deviation is 7,2%, the highest among 14 records of 17 buckets.

The extent of the present paper does not allow to present the diagrams of each of 17 buckets, but analyzing them together it is evident that distances from C are above the average, and those from D are located below the average, which is better illustrated by the location of corresponding partial averages marked on diagrams with green lines above each group of measured distances. 71% of buckets were deformed in such of manner that C values increased while D values decreased. By our opinion, this is due to the general overload during excavation and the intrinsic characteristic of asymmetrical shape of the bucket.

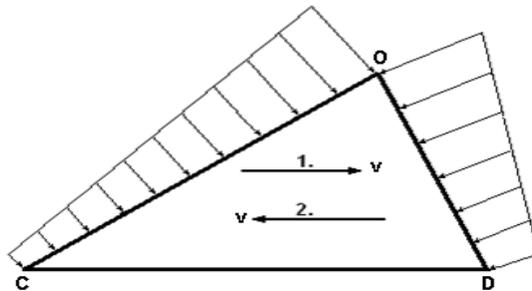
Fig. 10. Triangular shape model of the bucket

In the figure 10 we modeled the bucket with a triangular shape frame, taking into account the load carrying aspect. The asymmetric character has been represented by the non-equilateral shape of the triangle. The figure illustrates that in case of slewing direction marked with 2 the structure exposes a lower rigidity than in case of opposed slewing direction, marked with 1. In this last case, it can be seen that the

CO element is able to support the resultant forces acting on DO element. In the opposite case, the DO capability to balance the forces acting on CO segment is lower than previous. So, in case of overload, the structure is more exposed to be deformed in case of 2 slewing direction.

This assumption is confirmed by the fact that in reality the DO segment is more frequently damaged (bending, failure, rupture). When slewing in direction 2, the bucket avoids the increased load, by deformation, the rigid support in case of slewing in direction 1 the DO side is more exposed to failure.
