EXAMINING THE BUCKET WHEEL EXCAVATOR'S BUCKET AFTER RENEWAL

Abstract: The Department of Geotechnical Equipment is involved since two decades in research and development of teeth, buckets and other active parts of different kinds of mining excavators. The actual study is devoted to reveal new difficulties arising when excavating in the sandstone as overburden rock, mainly regarding the buckets of Bucket Wheel Excavators. As a consequence of the increased cutting forces, the buckets suffer deformations. In case of the change of cutting geometry, as a result of renewal (strengthening) of buckets, the winning becomes no-optimal and there will be more breakdowns. The investigations made and reported in the actual paper led to provide guidelines for a better renewal method of buckets.

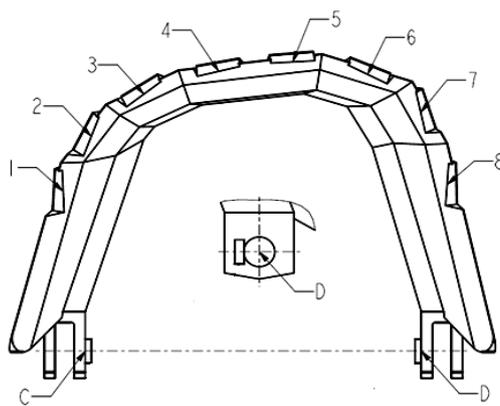
Fig.8. Measure points of blade geometry verification

In this respect, the examination measurements were focused on the verification of the bucket's and connected part's. This task has been performed by measuring the diagonal point to point distances between the numbered points as in figure 8 (from point C to 2...8 and from point D to 7...1). Accordingly, we measured for each bucket 14 distances, which is an overall amount of 238 measurements on 17 buckets, which is enough to have a statistical population. The measured distances selected for verification of the shape (geometry)

In selecting measurement points and distances we considered those which are accessible and usable even in case of worn buckets. That is the reason for which we selected the points as in figure 8, and the diagonal distances between each bucket connecting pin center (C and D) and the center points of teeth lips supporting cavities on the blade. For reasons of comparison possibility, we calculated the relative deviation of each measured value related to the average. The corresponding data were drawn out for each bucket, as an example the diagram for the bucket no. 14 is presented in figure 9.
